BASS LAKE, STARKE COUNTY
AQUATIC PLANT MANAGEMENT
PLAN UPDATE 2007

DECEMBER 14, 2007

Executive Summary

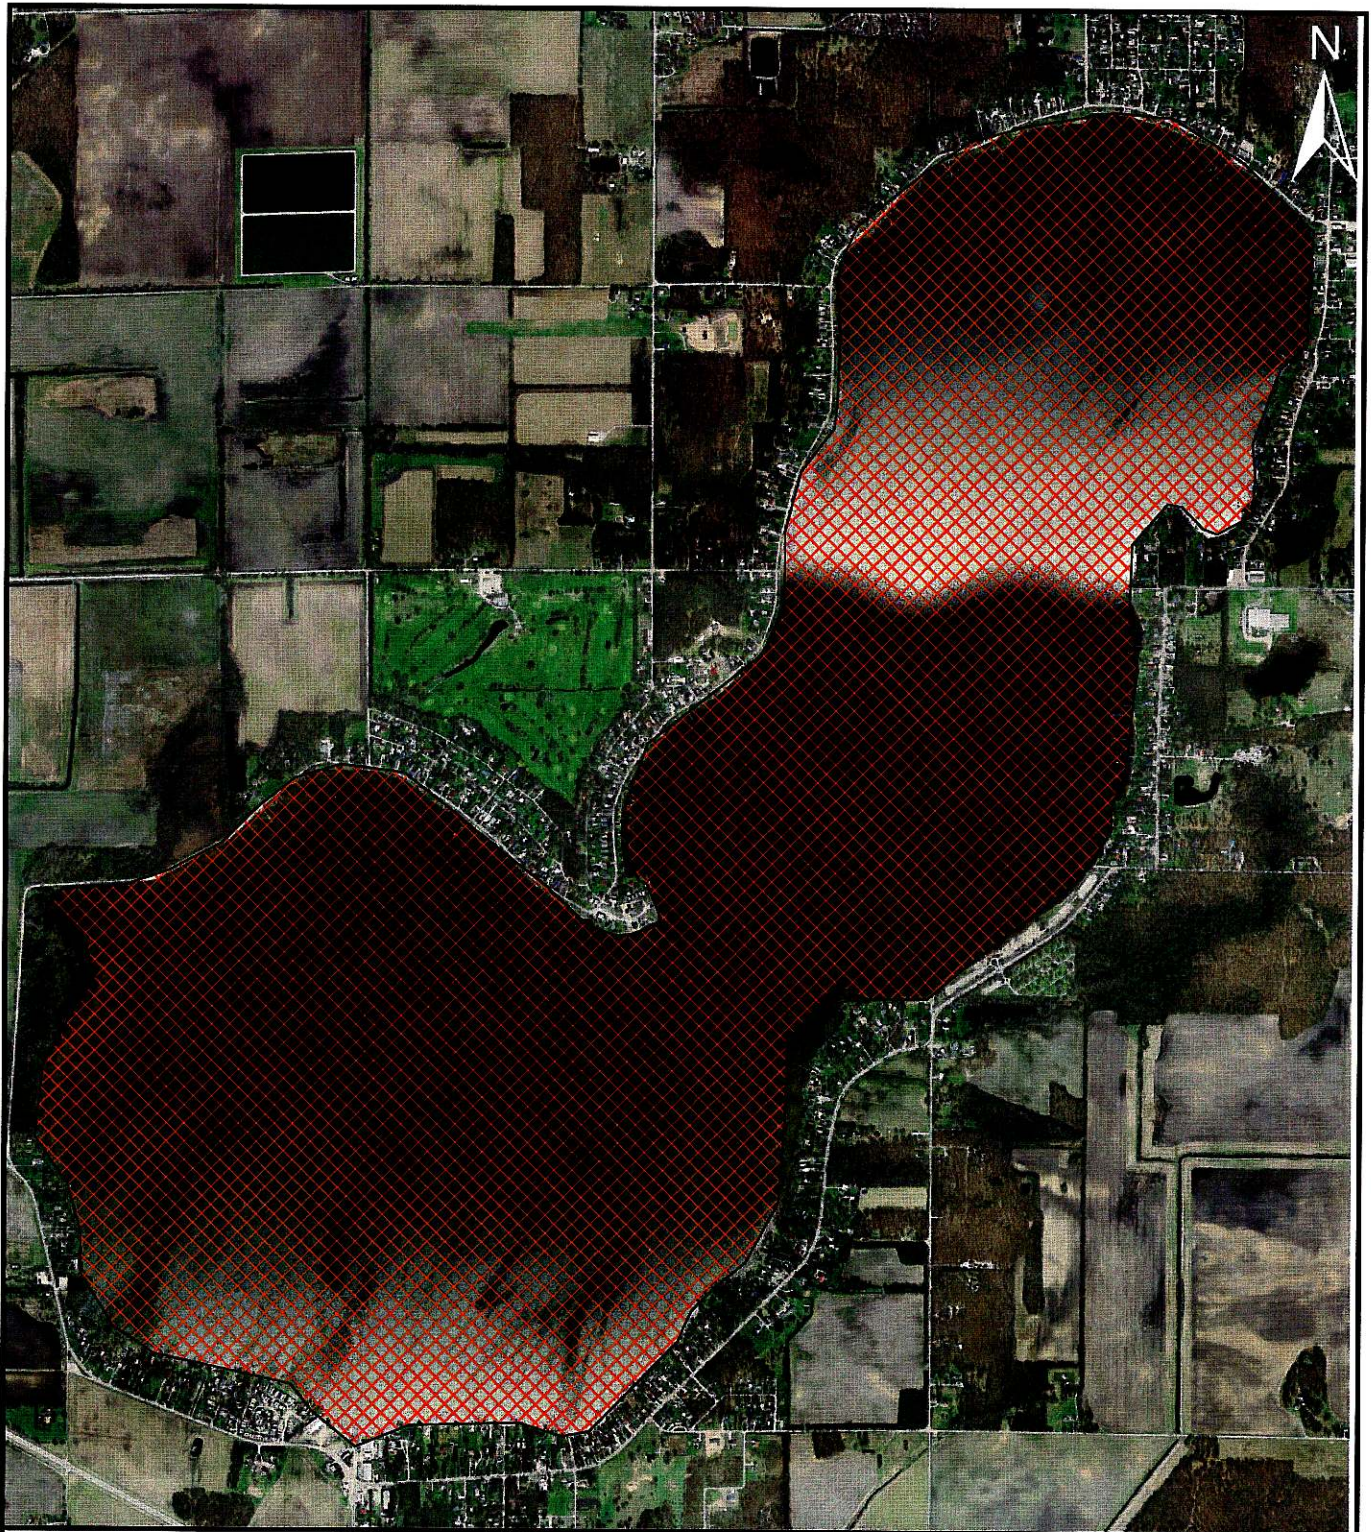
<p>V3 Companies 7325 Janes Avenue Woodridge, IL 60517 630.724.9200 phone 630.724.9202 fax www.v3co.com</p>	TITLE: Bass Lake Sonar Treatment Area	PROJECT: Bass Lake Aquatic Plant Management Plan		
	BASE LAYER: Indiana Spatial Data 2006 Orthophotography	PROJECT NO. 07122	EXHIBIT: II	SHEET: 1 OF: 1
	CLIENT: Bass Lake Conservancy District 3620 South CR 210 Knox, IN 46534	QUADRANGLE: Starke	DATE: 12/12/07	SCALE: 1"=20500'

Bass Lake was treated with a Sonar aquatic herbicide on May 14, 2007 (Exhibit II). Treatments on Bass Lake should be continued over the next two to three years, targeting areas of new growth, to ensure Eurasian watermilfoil doesn't become the dominant species within Bass Lake.

Weed Patrol performed a whole lake fluridone treatment herbicide application on May 14, 2007 with a concentration of 7 parts per billion (Exhibit II). A second treatment of 3 ppb, or bump, was applied on June 15, 2007 in order to maintain the fluridone concentration within the lake. The Tier II sampling effort on August 6, 2007 indicated success of treatment. No areas of Eurasian watermilfoil beds were identified and much of the plant material collected was dead or decaying.
